# Illinois Department of Transportation

## Memorandum

**To:** Thomas R. Sancken                      Attn: Bill Raffensperger  
**From:** Kenneth R. Lang                      By: Terry McCleary  
**Subject:** Pavement Recommendations\*      ✓  
**Date:** August 11, 2004

FAP 326 (IL 47)  
Section (111 CS)W & RS-2,I  
Grundy County  
P93-058-02  
D3# 1514

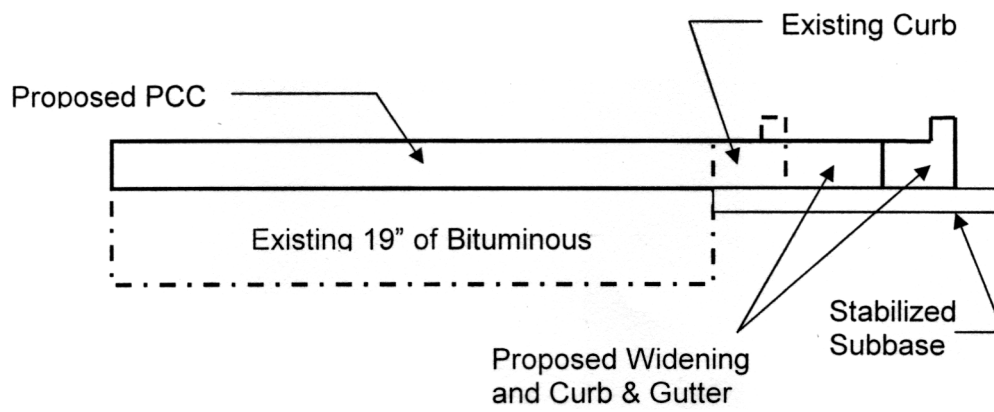
We have resurfaced this portion of IL 47 numerous times over the last eight years. We have tried very hardy mixes, slag mix, and the pavement is still rutting under the traffic load. The vehicles are braking coming down the hill from the north and off the bridge from the south. In the opposite lanes, they are accelerating to get up the hill to the north and over the bridge to the south. We recommend milling and overlaying with concrete. The thickness of bituminous removal is contingent on proposed grade changes and PCC thickness.

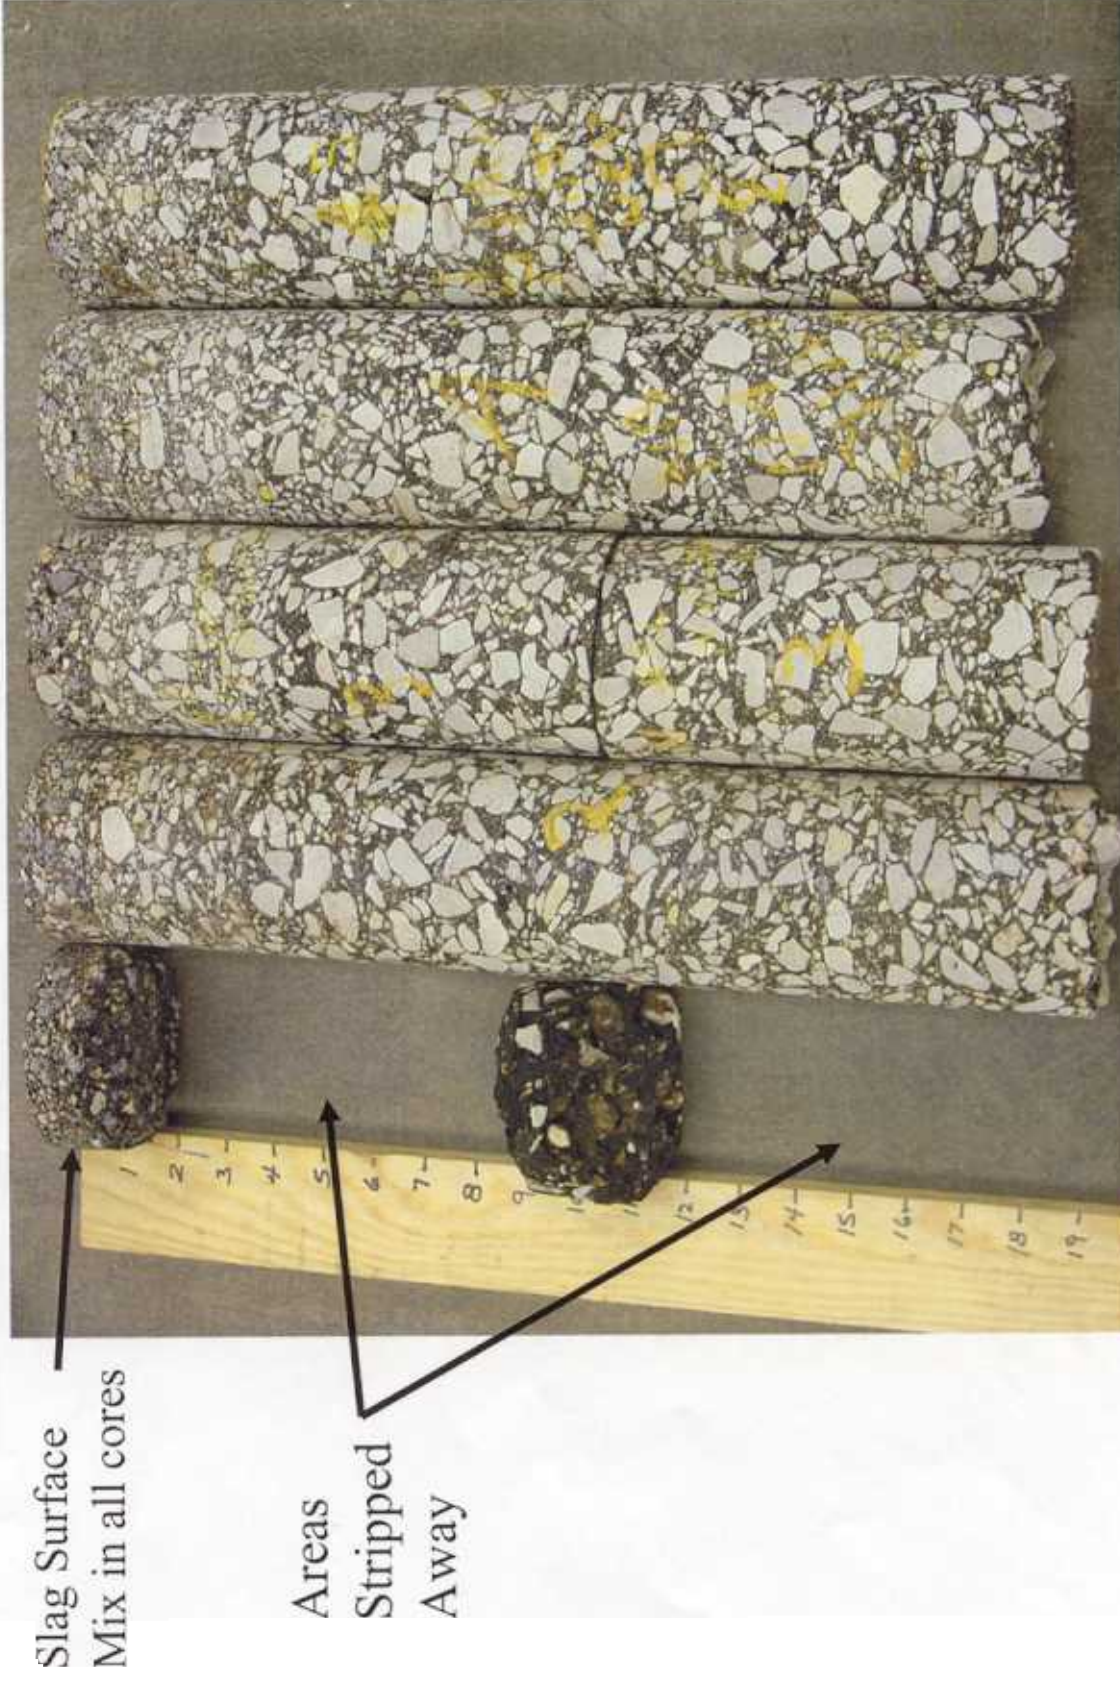
# IL 47 between Benton St. & Main St.

Slag Surface

Mix in all cores

Areas

Stripped

Away

Core #1

#5
